Case Study: Chatter Resolution in Cold Mill

R. Evans
April 2013

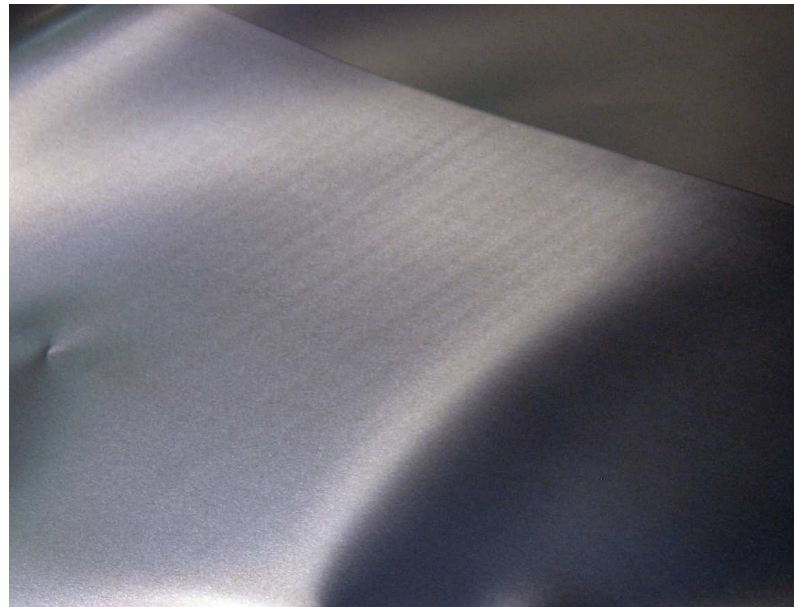
- **At speeds > 600 m/min transverse lines visible across sheet**
- **Spacing approximately 22 mm**
- **Not visible at speed < 600 m/min**

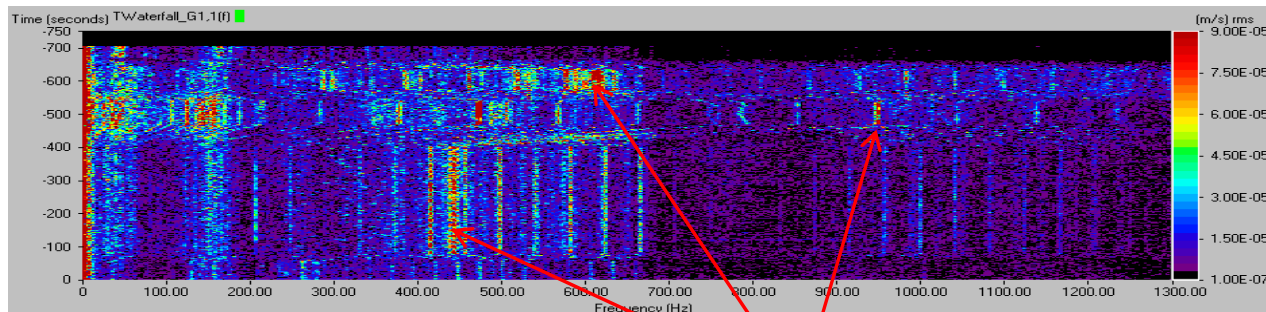
Top Back-up - OS

- **Not resonance issue**
 - Defect is visible in accelerometer measurements at all speeds
- **Evaluation of hydraulics/couplings showed no issues**
 - Calculated frequencies did not match visible defect
- **Calculated frequencies closely matched bearing defect in BUR**
 - Not exact match

22 mm markings

- **Ran trial with new BURs and bearings**
 - No defects at any speed
 - Combinations of new/old BURs and bearings
 - Defects visible both old BUR/new bearings & new BUR/old bearings
 - Suggested bearing upgrades to allow full speed with all rolls
 - Suggested maintenance/upgrades to grinders to eliminate “ground-in” defect
- **Developed online monitoring system for detection of defect at all times**
 - iba based system tied directly to plant data acquisition

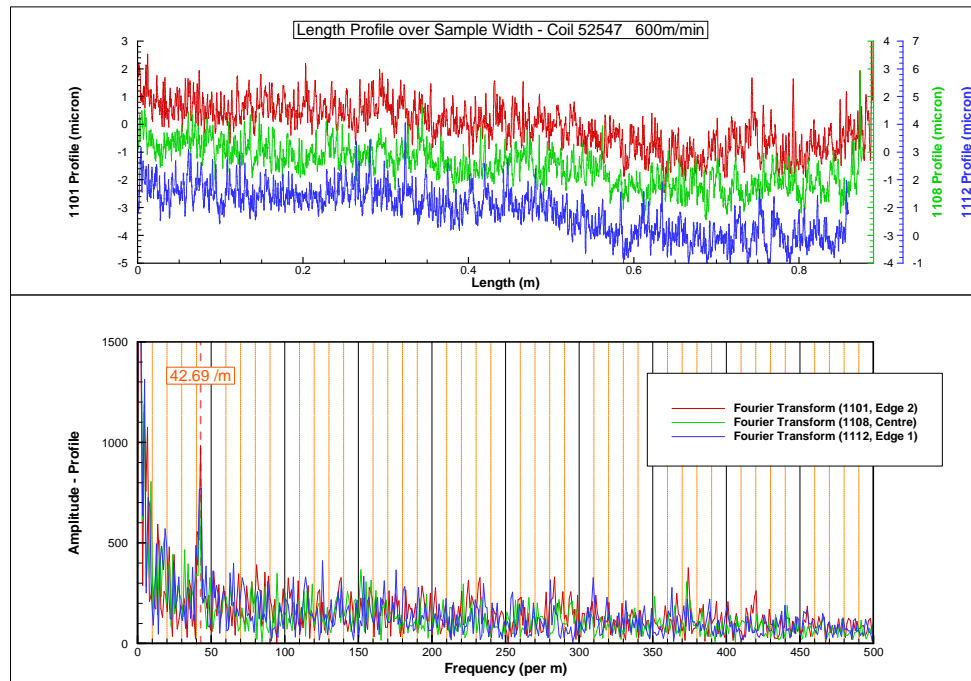
- **Proved defect present at all speeds**
 - Not visible to naked eye below 600 m/min but still present (plant equipment)

42.69/m = 22mm defect spacing

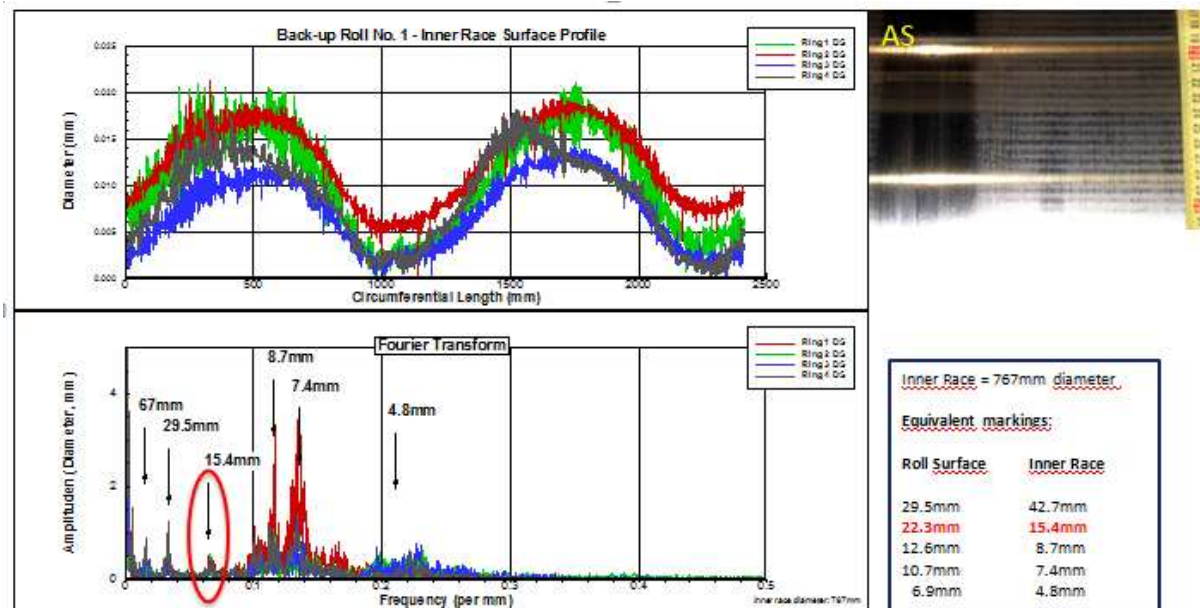
- Evaluation of roll grinders showed rolls were being ground with defects
- Evaluation of roll surfaces (plant equipment) demonstrated that surface was marked
 - Origin found to be bearing journals on roll necks
